GMC

SYCLONE

**MASTER TECHNICIAN
OVERVIEW**

LEADER GUIDE

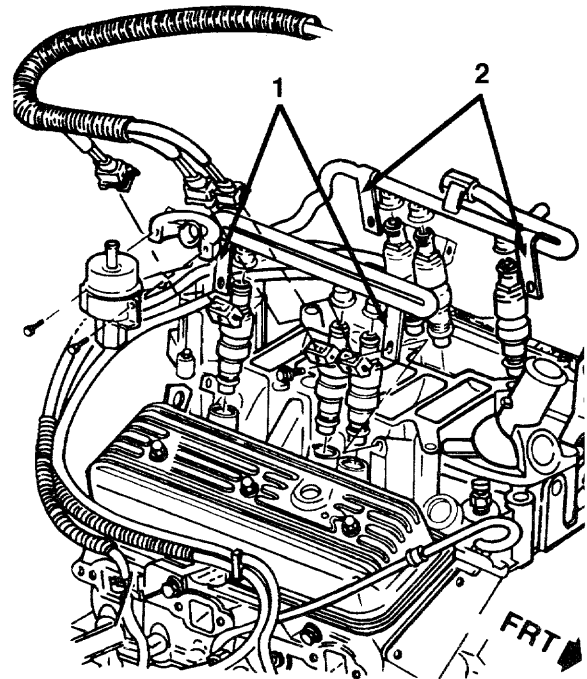
Injector noise is caused by the fuel rails seated too tightly into the intake manifold, causing the fuel injectors to make contact. The repair procedure involves increasing the height of the fuel rail, thus relieving the metal to metal contact of the fuel injectors to the manifold. This depressed fuel rail condition can also cause the fuel to boil in the fuel rail because heat is transferred directly from the intake manifold through the injectors to the rail. This can cause poor engine performance. (See Service Bulletin #92-6C-51.)

- (1) Passenger Side Fuel Rail Bracket
(2) Driver Side Fuel Rail Bracket

- 1 On a cool engine, loosen the passenger side fuel rail brackets (1).
- 2 Then loosen the driver side fuel rail brackets (2).
- 3 Raise the passenger side fuel rail as far as the bracket slots (1) permit, tighten the bolts.
- 4 Raise the driver side fuel rail as far as the fuelrail bracket (2) permits, tighten the bolts. This should correct the injector noise and heated fuel rail condition.

- 1 Depression of the fuel rail can only be caused by bent brackets, forcing the rail down. Straighten the bent brackets to raise the fuel rail height. This should correct the injector noise and heated fuel rail condition.

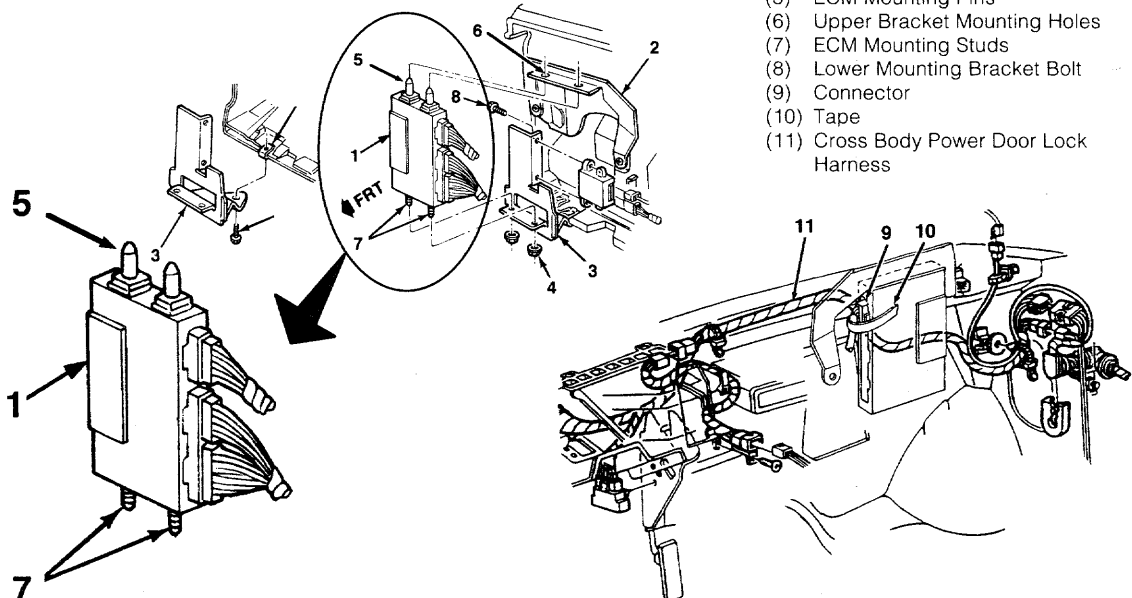
Syclones built before VIN 1521 may experience overboost due to ECM wiring harness chaffing against the upper mounting bracket. It is necessary to repair the wires and install a new mounting bracket assembly to correct this condition. (Campaign 91-C-12.) NOTE: Normally this chaffing occurs with the green/white to black wire.

- (1) ECM Assembly
- (2) Upper Mounting Bracket
- (3) Lower Mounting Bracket
- (4) Nut
- (5) ECM Mounting Pins
- (6) Upper Bracket Mounting Holes
- (7) ECM Mounting Studs
- (8) Lower Mounting Bracket Bolt
- (9) Connector
- (10) Tape
- (11) Cross Body Power Door Lock Harness

- 1 Disconnect the negative (-) battery cable.
- 2 Disconnect ECM wiring harness.
- 3 Remove the ECM from the upper bracket.
- 4 Remove the upper mounting bracket.
- 5 Repair the "chaffed" wiring harness in the approved GM manner.

- 1 Mount upper mounting bracket (2) to the I.P.
- 2 When installing the ECM into the passenger compartment, position the wire out of the top (green) connector (9) between the connector thumb latch and the tab on grey comb. IMPORTANT: Place tape (10) to retain wire in this position during ECM installation. To avoid interference, it will be necessary to move the cross body power door lock harness (11) prior to ECM installation.
- 3 Mount the ECM (1) into the upper mounting bracket (2) by inserting the ECM mounting pins (5) into the upper bracket mounting holes (6).
- 4 Secure the lower mounting bracket (3) to the I.P. using the lower mounting bracket mounting bolt (8).
- 5 Install right hush panel.
- 6 Reconnect negative (-) battery cable.
- 7 Verify all ECM functions with a Tech Scan tool.

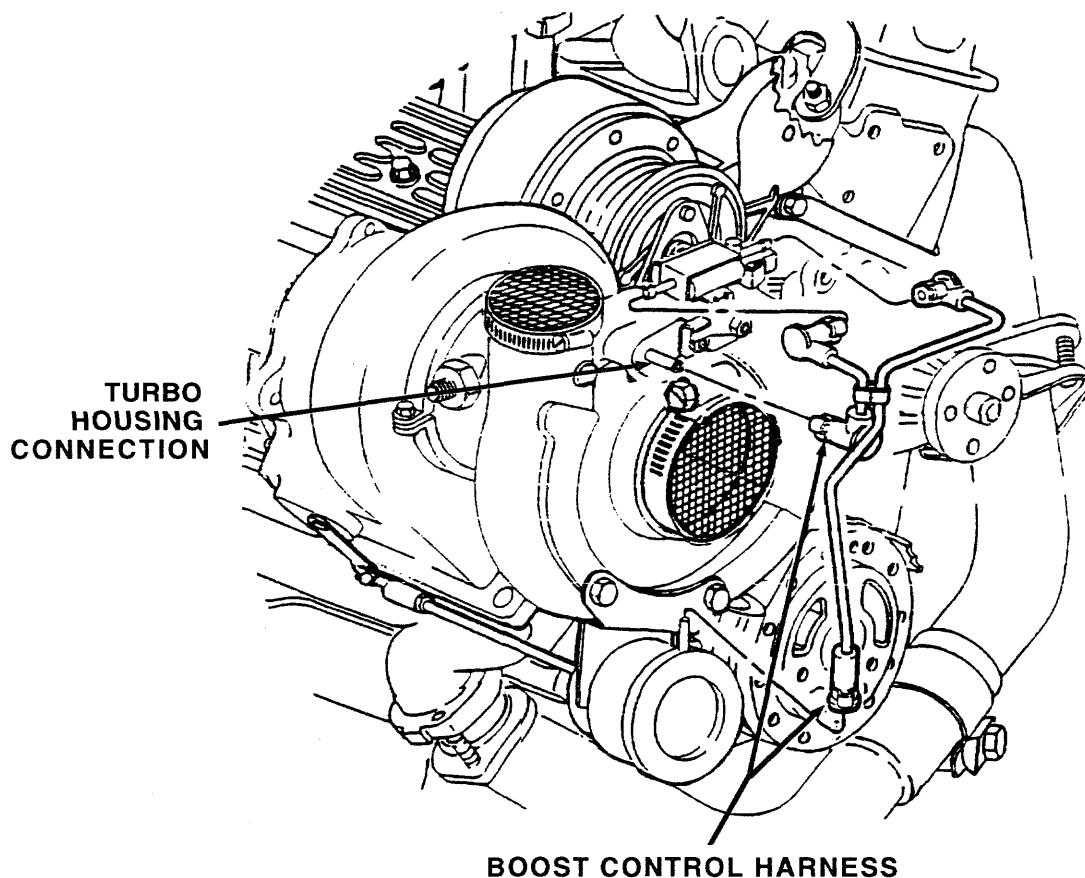
BOOST CONTROL HARNESS

- The Boost Control Harness (located on the turbocharger) installs to the compressor housing with a rubber elbow. If this elbow is forced on to the compressor so that the rubber actually touches the aluminum compressor housing, the boost control cannot operate correctly since the hose nipple is bottoming inside the elbow and blocking off boost pressure. With a screwdriver, pry between the compressor housing and the rubber elbow to obtain approximately 1/8 of an inch clearance.

NOTE: Removal of muffler or catalytic converter will cause Code 31 due to a boost "spike".

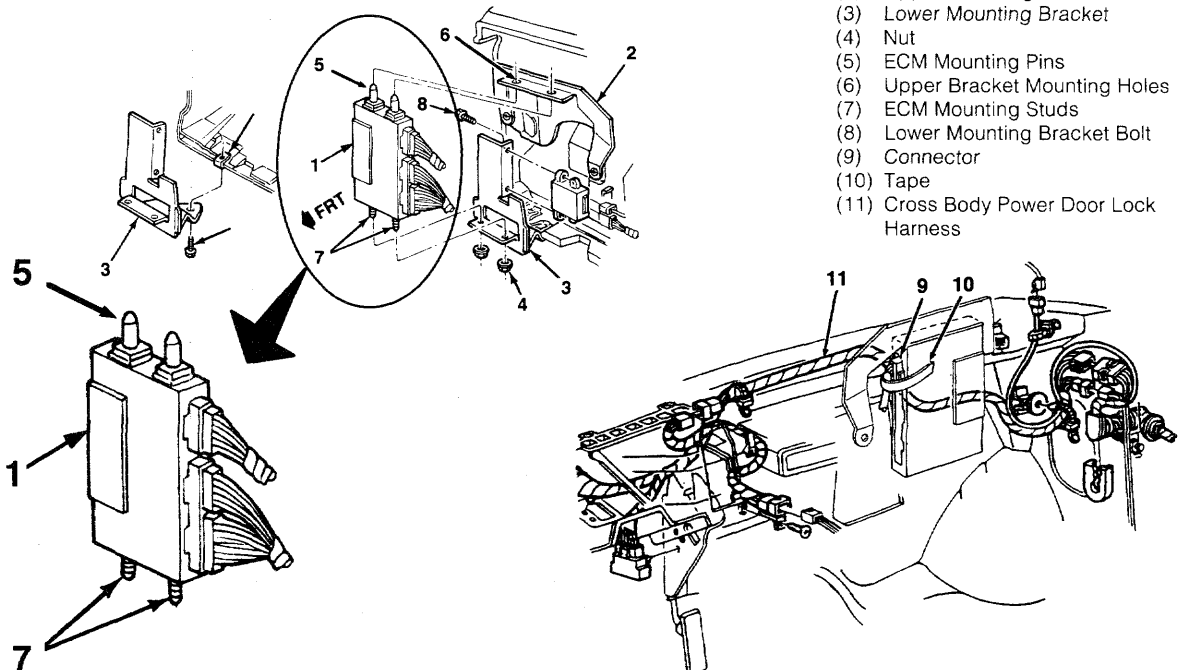
Syclones built before VIN 1521 may experience overboost due to ECM wiring harness chaffing against the upper mounting bracket. It is necessary to repair the wires and install a new mounting bracket assembly to correct this condition. (Campaign 91-C-12.) NOTE: Normally this chaffing occurs with the green/white to black wire.

- 1 Disconnect the negative (-) battery cable.
- 2 Disconnect ECM wiring harness.
- 3 Remove the ECM from the upper bracket.
- 4 Remove the upper mounting bracket.
- 5 Repair the "chuffed" wiring harness in the approved GM manner.

- 1 Mount upper mounting bracket (2) to the I.P.
- 2 When installing the ECM into the passenger compartment, position the wire out of the top (green) connector (9) between the connector thumb latch and the tab on grey comb. IMPORTANT: Place tape (10) to retain wire in this position during ECM installation. To avoid interference, it will be necessary to move the cross body power door lock harness (11) prior to ECM installation.
- 3 Mount the ECM (1) into the upper mounting bracket (2) by inserting the ECM mounting pins (5) into the upper bracket mounting holes (6).
- 4 Secure the lower mounting bracket (3) to the I.P. using the lower mounting bracket mounting bolt (8).
- 5 Install right hush panel.
- 6 Reconnect negative (-) battery cable.
- 7 Verify all ECM functions with a Tech Scan tool.

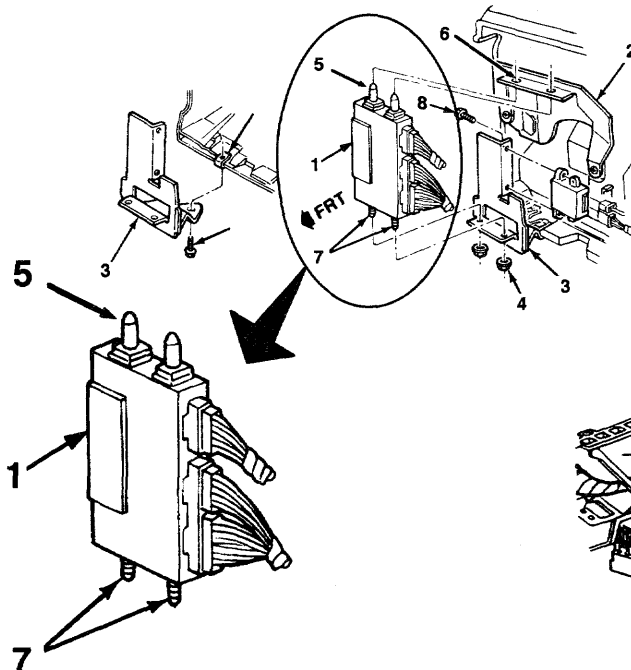
- (1) ECM Assembly
- (2) Upper Mounting Bracket
- (3) Lower Mounting Bracket
- (4) Nut
- (5) ECM Mounting Pins
- (6) Upper Bracket Mounting Holes
- (7) ECM Mounting Studs
- (8) Lower Mounting Bracket Bolt
- (9) Connector
- (10) Tape
- (11) Cross Body Power Door Lock Harness

- 1 Mount upper mounting bracket (2) to the I.P.
- 2 When installing the ECM into the passenger compartment, position the wire out of the top (green) connector (9) between the connector thumb latch and the tab on grey comb. **IMPORTANT:** Place tape (10) to retain wire in this position during ECM installation. To avoid interference, it will be necessary to move the cross body power door lock harness (11) prior to ECM installation.
- 3 Mount the ECM (1) into the upper mounting bracket (2) by inserting the ECM mounting pins (5) into the upper bracket mounting holes (6).
- 4 Secure the lower mounting bracket (3) to the I.P. using the lower mounting bracket mounting bolt (8).
- 5 Install right hush panel.
- 6 Reconnect negative (-) battery cable.
- 7 Verify all ECM functions with a Tech Scan tool.

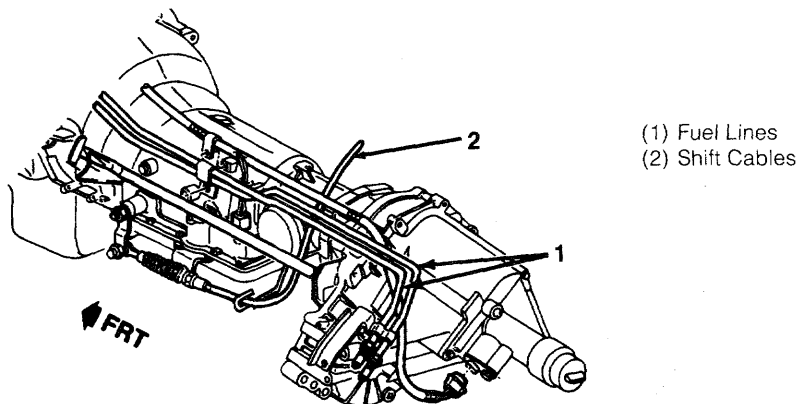
- 2 Fuel line is vibrating against the shift cable.

Correction: It is generally not necessary to remove the shifter cable to obtain clearance from the fuel line. Re-index the shifter cable by turning the cable housing at the cable bracket on the transmission. Adjust fuel line to achieve clearance from the shift cable.

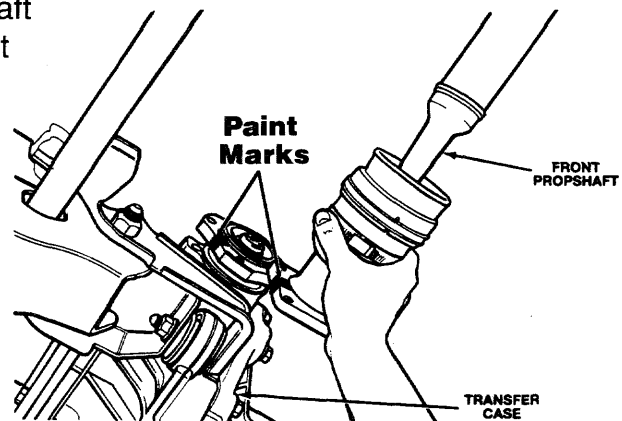
FRONT PROPSHAFT INDEXING

- When replacing the front propshaft in either a Syclone or Typhoon, it is critical that the white painted stripes on the front axle flange and the propshaft are lined up and that the propshaft is seated properly against the flange before the bolts are installed. If one or both of these steps are not done, the result could be vibration.
