GMC

SYCLONE

**MASTER TECHNICIAN
OVERVIEW**

LEADER GUIDE

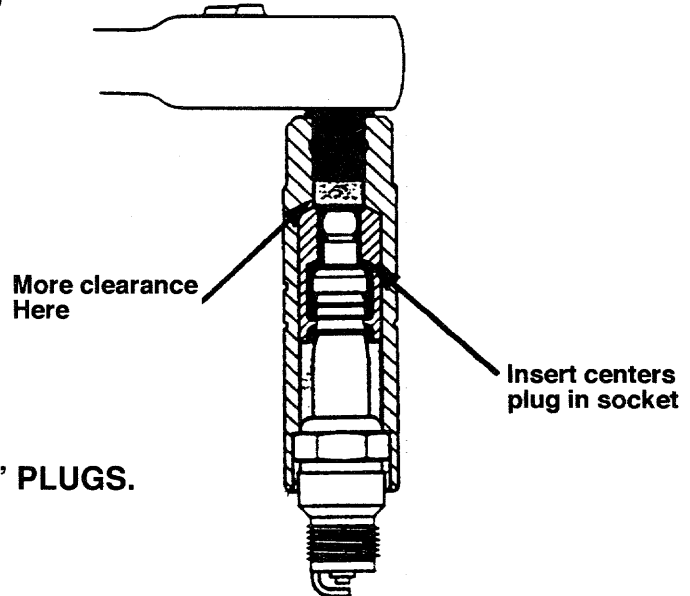
- The Cyclone and Typhoon use the Quantum Plugs, which, among other differences, are longer than the plugs that you routinely work with. Because of this longer length, you'll have to use Snap-On tool #S9706KA spark plug socket or equivalent to service the plugs.

NOTE: Always replace spark plugs with: CR42TS

NEVER REPLACE WITH "HOTTER" PLUGS.

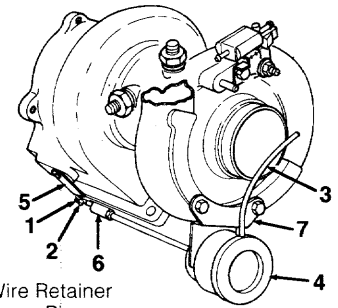
- 7 If adjustment causes wastegate to open at all, replace the wastegate actuator.
- 8 Remove tools J 8001-3 and J 35691.

- 1 Install new clamp (7) on boost control hose (3). (These can be obtained through TAC.)
- 2 Connect the boost control hose (3) to wastegate actuator (4).
- 3 Correctly position on hose end and crimp clamp onto hose. Clamp must prevent hose from being capable of pulling off actuator.
- 4 Connect the retaining wire (1) to pin (2).
- 5 Install the passenger side wheelhouse panel.

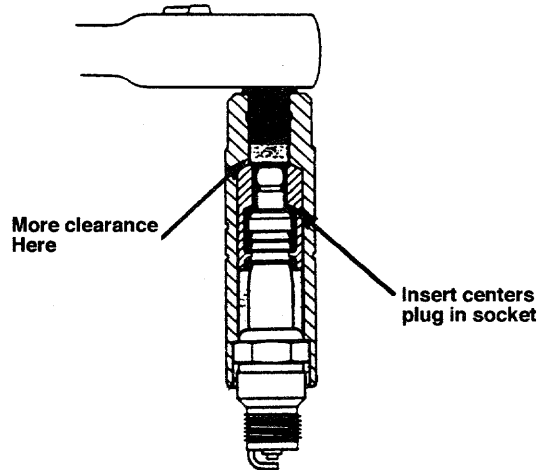
The Syclone and Typhoon use the Quantum Plugs, which, among other differences, are longer than the plugs that you routinely work with. Because of this longer length, you'll have to use Snap-On tool #S9706KA spark plug socket to service the plugs.

NOTE: Always replace spark plugs with: CR42TS

NEVER REPLACE WITH "HOTTER" PLUGS.

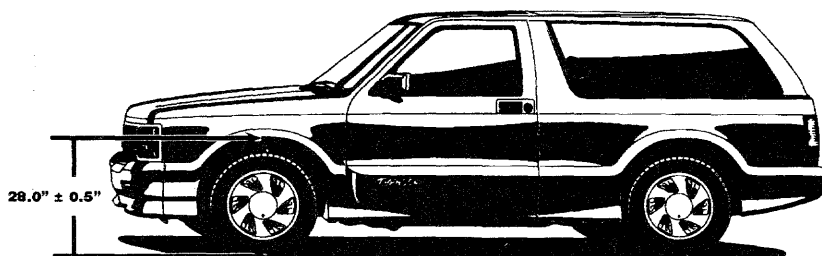
■ FRONT WHEEL OPENING MEASUREMENT

- Measure the distance between the top edge of the front wheel opening and the ground. The correct height should be 28" plus or minus .5". If you find a difference from this height, look for tampering and correct the condition.

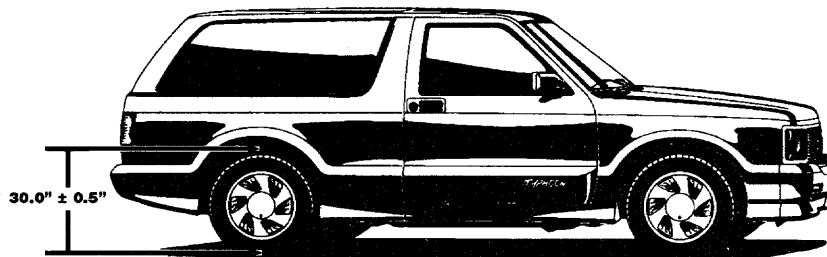
■ REAR WHEEL OPENING ADJUSTMENT

The proper ride height can be determined by measuring the distance from the top of the wheel opening to the ground. The correct height should be 30" plus or minus .5". If you find a difference from this height, look for tampering and correct the condition.

The Syclone rear trim height cannot be changed. If the actual measurement shows a significant difference from the 30 inches, look for tampering or owner abuse.

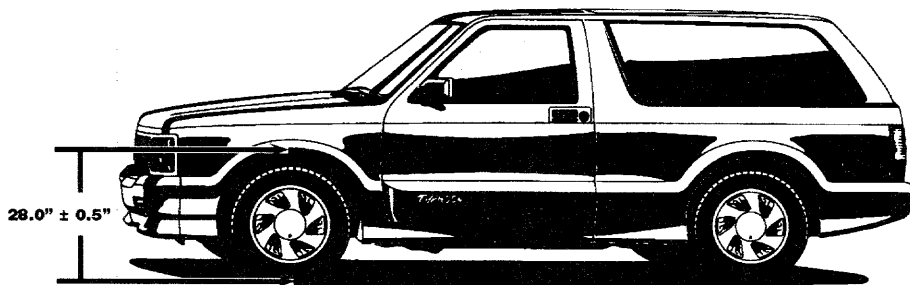
■ FRONT WHEEL OPENING MEASUREMENT

- Measure the distance between the top edge of the front wheel opening and the ground. The correct height should be 28" plus or minus .5". If you find a difference from this height, look for tampering and correct the condition.

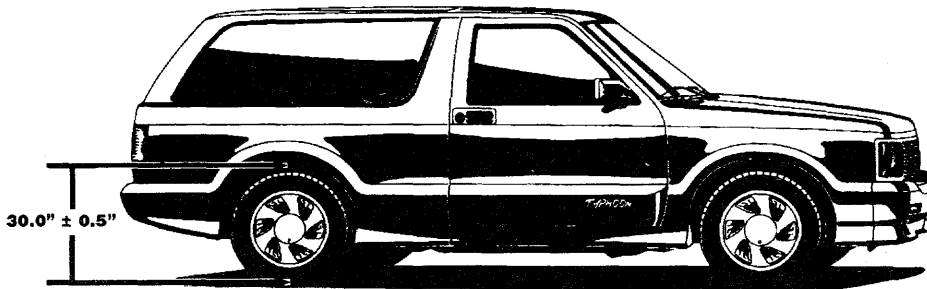
■ REAR WHEEL OPENING ADJUSTMENT

The proper ride height can be determined by measuring the distance from the top of the wheel opening to the ground. The correct height should be 30" plus or minus .5". If you find a difference from this height, look for tampering and correct the condition.

The Cyclone rear trim height cannot be changed. If the actual measurement shows a significant difference from the 30 inches, look for tampering or owner abuse.

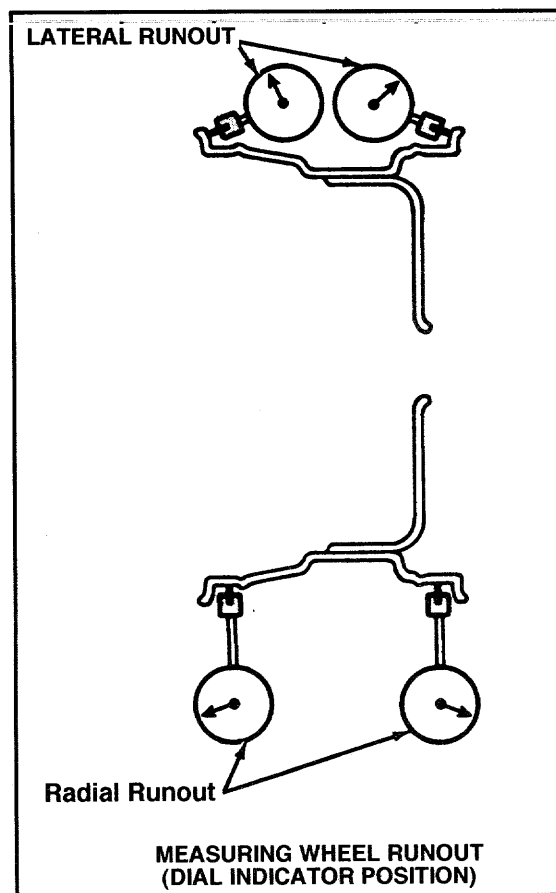
- The wheels on the Syclone and Typhoon are of lightweight welded construction of the cast center and rolled rim.
- These wheels are very sensitive to vibration resulting from deformation due to denting or out-of-specification manufacture. Should any of these wheels be found to be out of the .030" lateral or radial GM specification, they should be replaced under warranty.
- However, defective wheels found AFTER PDI should not be replaced until consultation with your DSM.

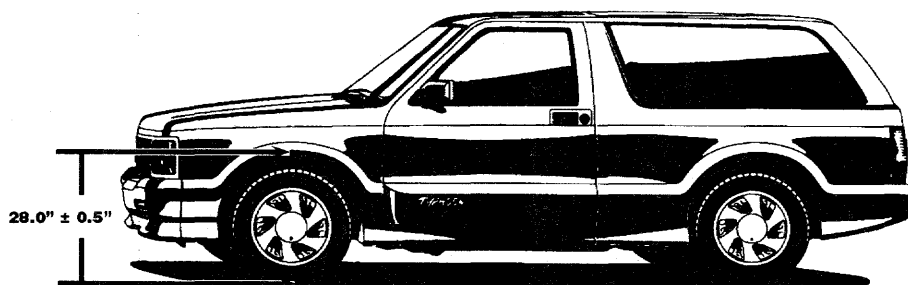
■ FRONT WHEEL OPENING MEASUREMENT

- Measure the distance between the top edge of the front wheel opening and the ground. The correct height should be 28" plus or minus .5". If you find a difference from this height, look for tampering and correct the condition.

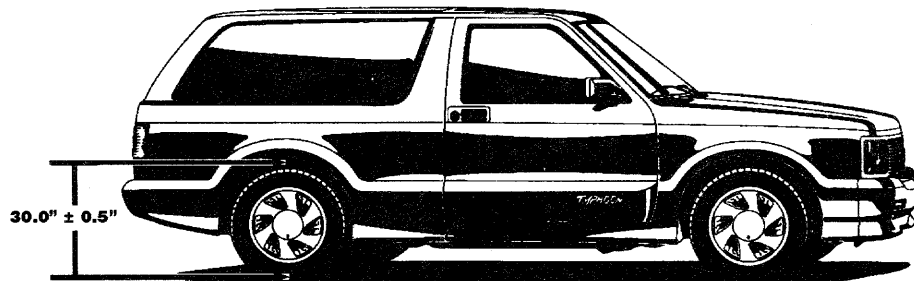
■ Rear Wheel Opening Adjustment

The proper ride height can be determined by measuring the distance from the top of the wheel opening to the ground. The correct height should be 30" plus or minus .5". If you find a difference from this height, look for tampering and correct the condition.

The Syclone rear trim height cannot be changed. If the actual measurement shows a significant difference from the 30 inches, look for tampering or owner abuse.
